LOW FRICTION HULL COATINGS
FOR ICEBREAKERS

PHASE III TECHNICAL REPORT

S.J. Calabrese and F.F. Ling
Department of Mechanical Engineering,
Aeronautical Engineering & Mechanics
Rensselaer Polytechnic Institute

OCTOBER 1978

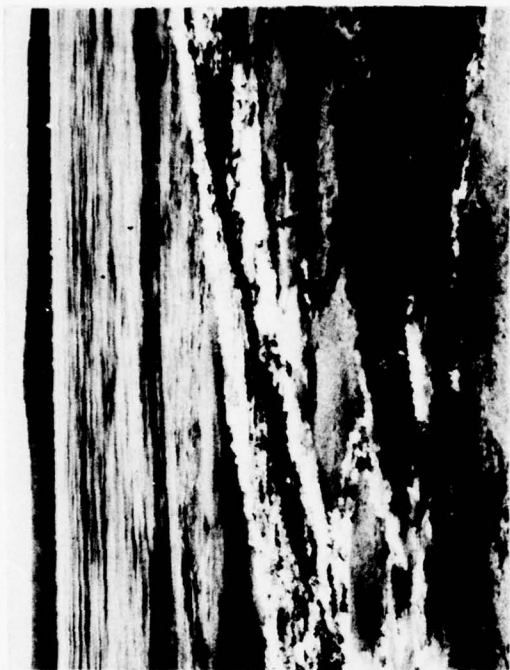
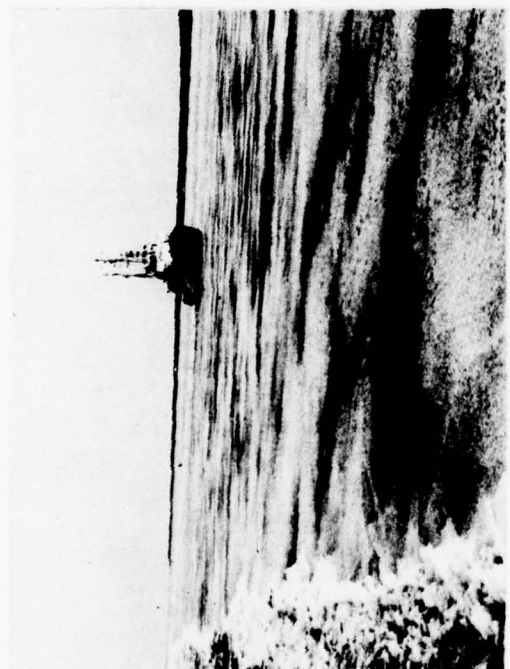
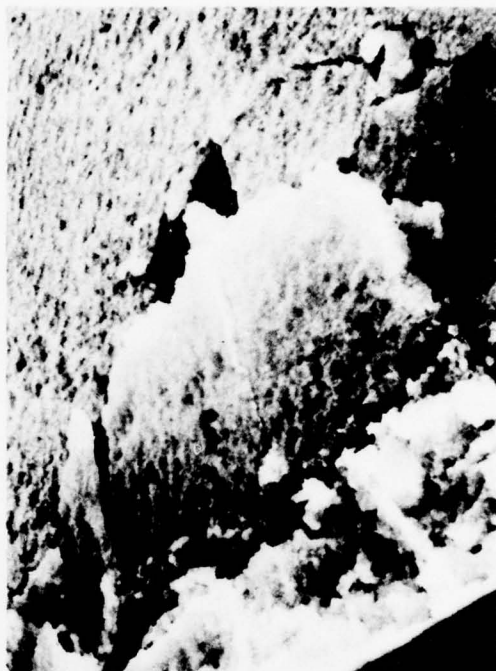
A second series of tests were run in a solid ice sheet field. The tests were inconclusive because of the condition of the ice. The tests were run in April when the ice had started to decay. The ice thickness ranged between 11 and 16" but the top 6" was soft with heavy pock marks. The results of the test were essentially the same as the brash ice except for one high point from both ships. Figure 6 shows the condition of the ice sheet during testing.

Figure 6 Condition of the Sheet Ice Field During Resistance Tests. Several inches of the top ice are heavily pock-marked and rotted.

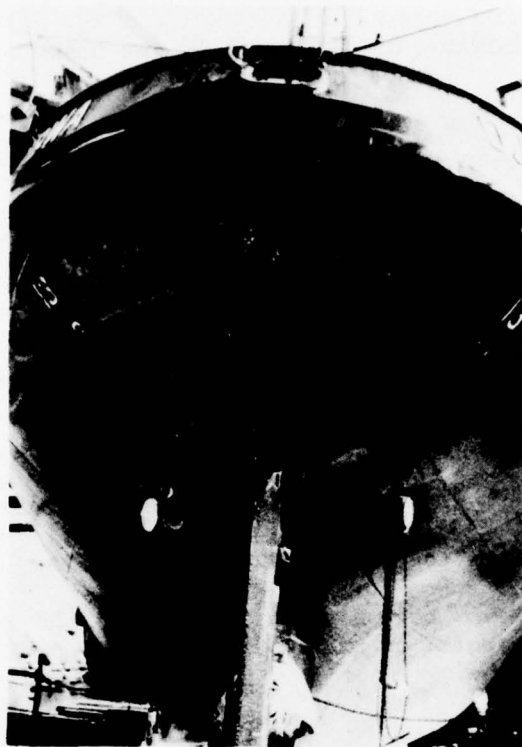
Figure 8 Condition of OJIBWA after 358 Hours of Icebreaking

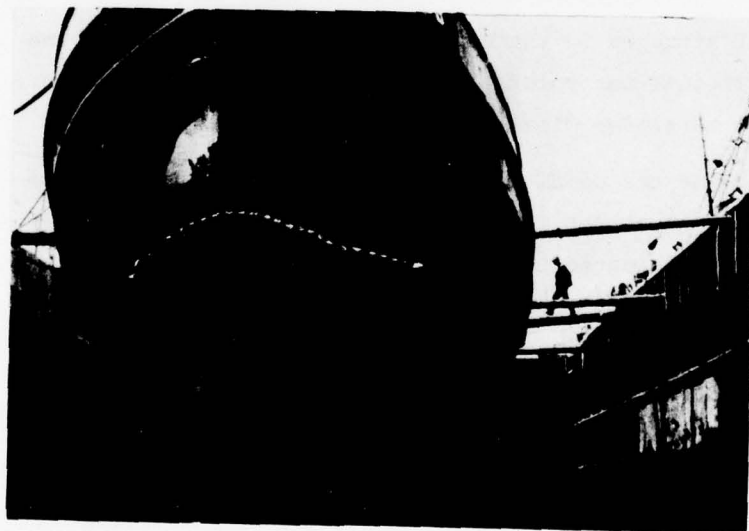
Figure 11 Condition of the USCG Cutter RARITAN after One Year, 600 Hours (Above) and Three Years, Approximately 1800 Hours (Below) of Icebreaking Service

coating is in the high wear and impact area. As of the winter of 1977 season (after approximately 1800 hours icebreaking service) there does not appear to be any wear on the under portion of the hull. The coating is still the original thickness and there is no evidence of corrosion. The only wear is at the ice line near the bow.

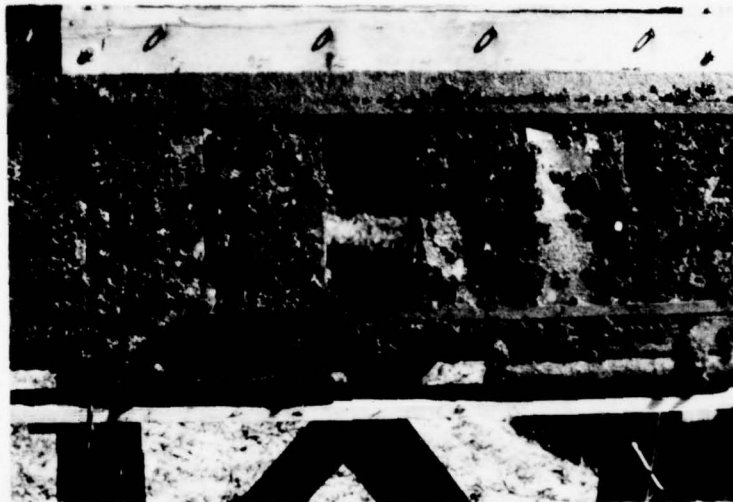
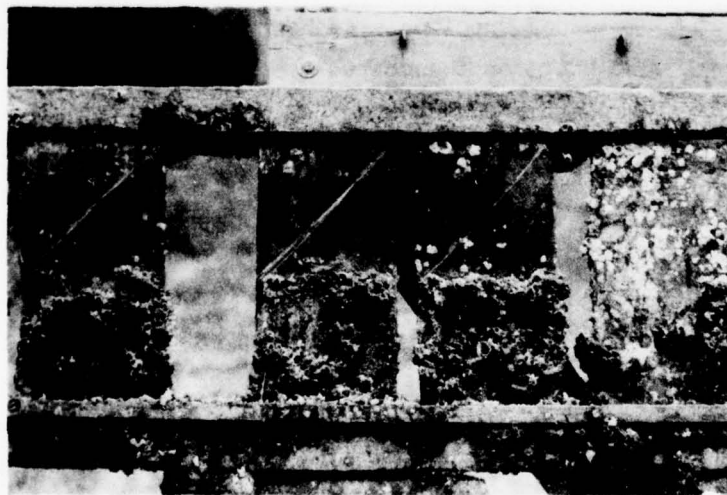
Figure 14 Condition of the Zebbron Coated Panels after Exposure for Six Months

but it could be removed from the panels without damage to the substrate. Crustaceans had lodged in the scribe line on the metal surface but they were unable to lift the coating. The penetration under the coating edge was less than 1/16" Figure 15 (upper) shows the condition of the surface as removed from the water and an area which was cleaned after removal. There was no damage to the coating but a slight discoloration was evident. Figure 15 (lower) shows the scribe line where the bare metal had been exposed. Note the barnacles which had attached to the metal but which did not lift the coating at the edge. The metal tangent to the scribe line was still intact. An attempt was made to peel the coating back from the edge but very little (approximately 1/8") of coating could be lifted. The substrate (steel) was still clean with no evidence of corrosion taking place beneath the Zebron. After 17 months of exposure to fouling and two cleanings the coating thickness remained between .028" and .032". There appeared to be no change in thickness.

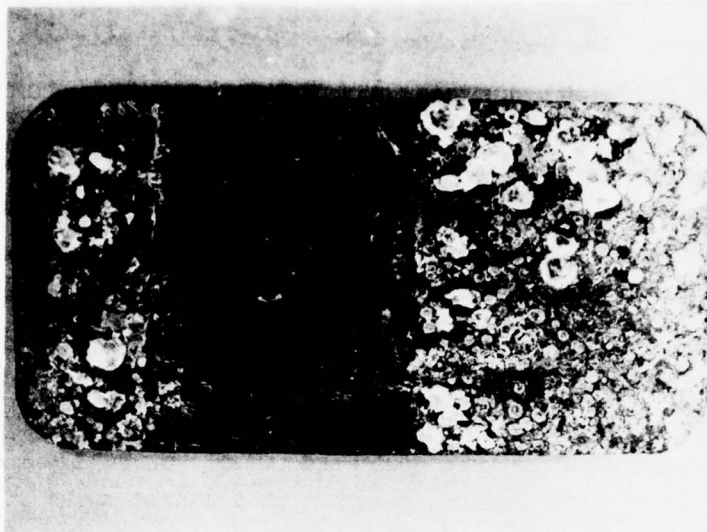
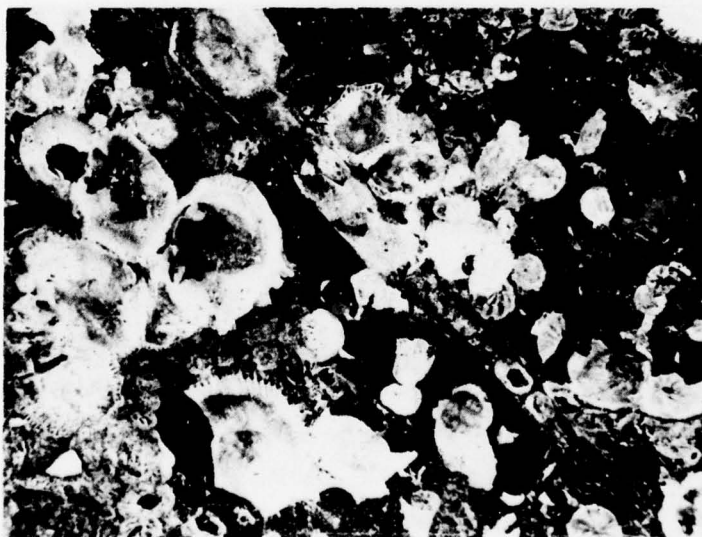
Figure 15 Condition of the Zebtron Coated Specimens after Removal from Fouling Exposure. Upper photograph shows the coating before and after cleaning. Lower photograph shows the condition of the scribe line where bare metal was exposed. Mag. 3X.

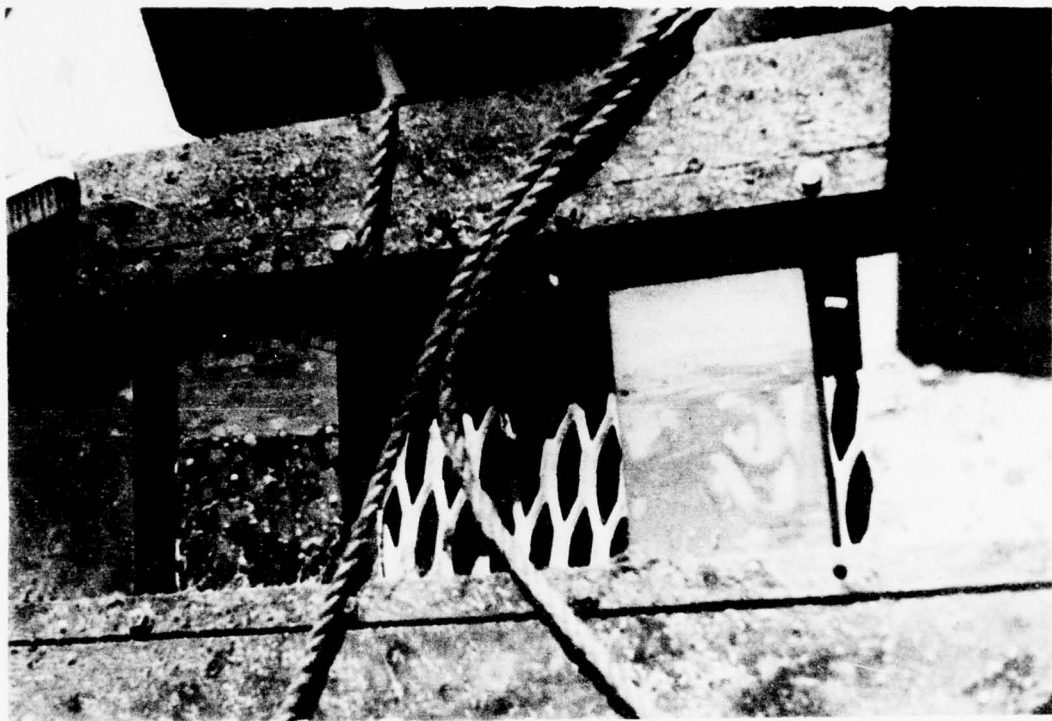
Figure 16 Condition of Test Panel after Four Months Exposure at Long Beach, California. A portion of the test specimen was cleaned by light brushing.

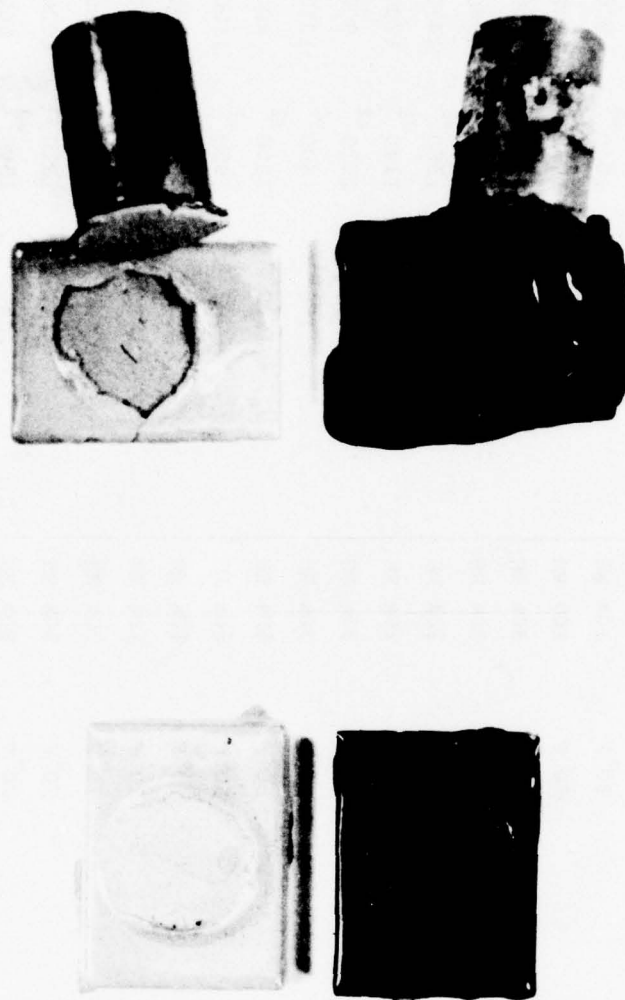
Figure 18 Typical Bond Strength Samples after Test. Gray specimen is nonsolvent polyurethane and black coating is non-solvent epoxy.

the coating on the steel. The lower photograph shown in Figure 18 shows the polyurethane failure (gray coating) to be partially in the coating and partially at the primer while the epoxy coating failure is all in the coating.
